CONTINUING ELIGIBILITY INSPECTION (CEI) REPORT
FOR FLOOD CONTROL PROJECTS

1. Project Name: KK Dam Flood Control Project

2. Date of Inspection: January 14, 2003

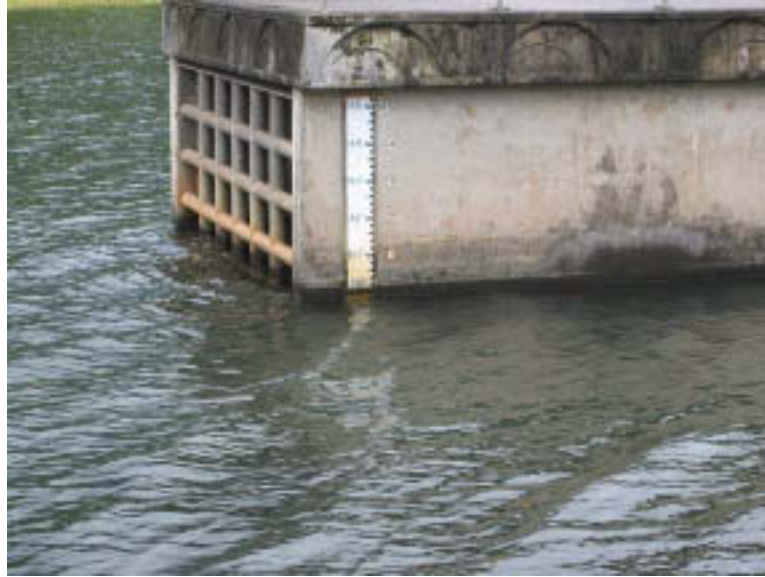
Close-up view of intake tower showing water level at 160 elev.

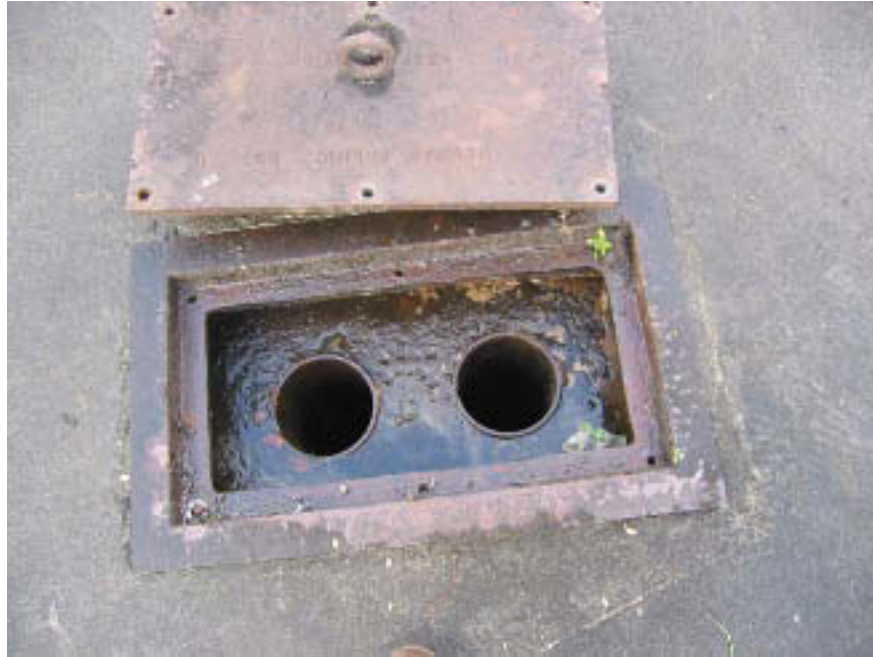
Sta. 5+75, Typical cleanout and cover for weep hole French drain system.

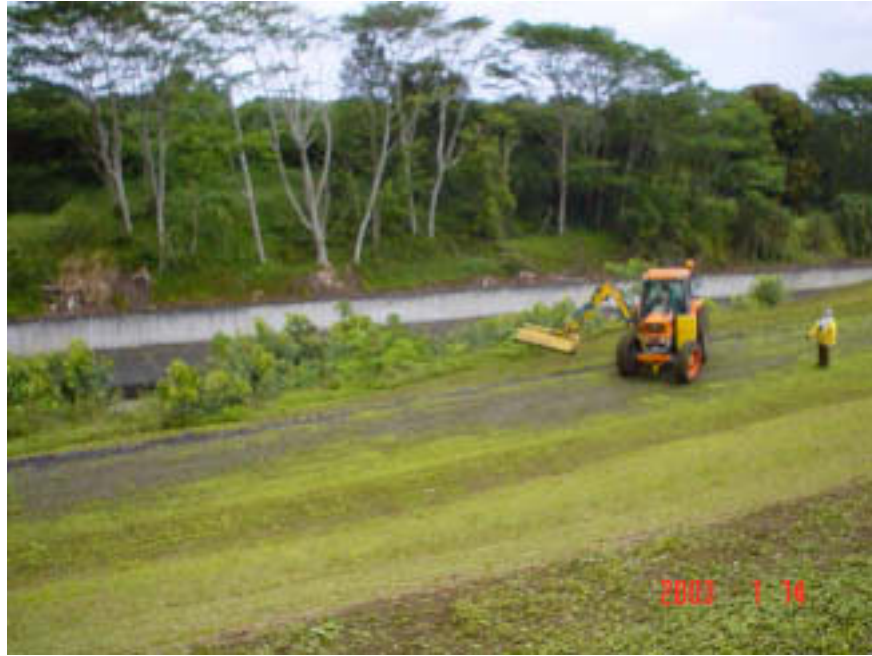
Sta. 11+50, Overview of dam slope, town side. Construction vehicles doing maintenance to remove trees and bushes between dam and spillway.

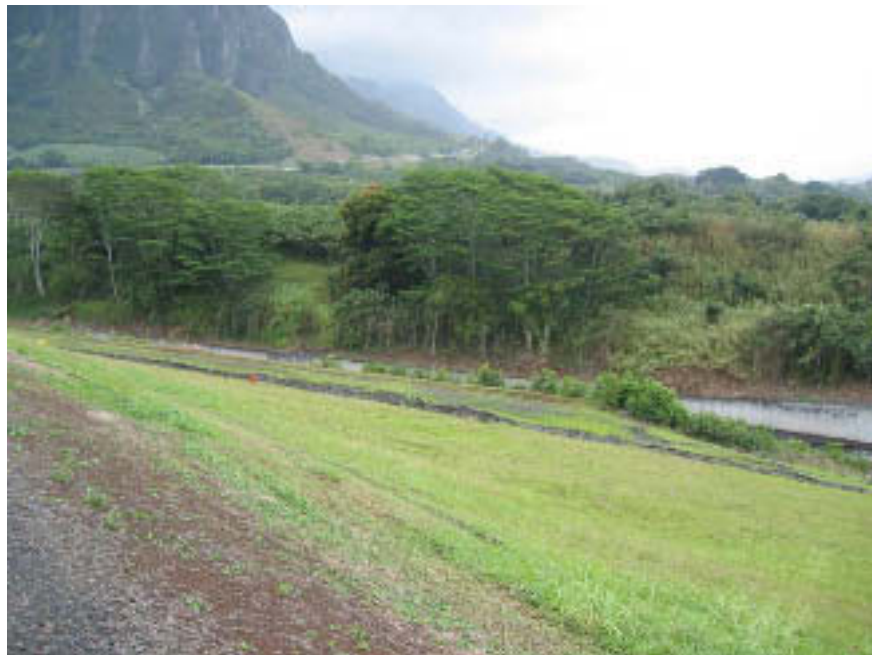
Sta. 12+00, Overview of French drain structure under rock cover. Electrical recorder box on dam crest has been removed as requested from the previous year.

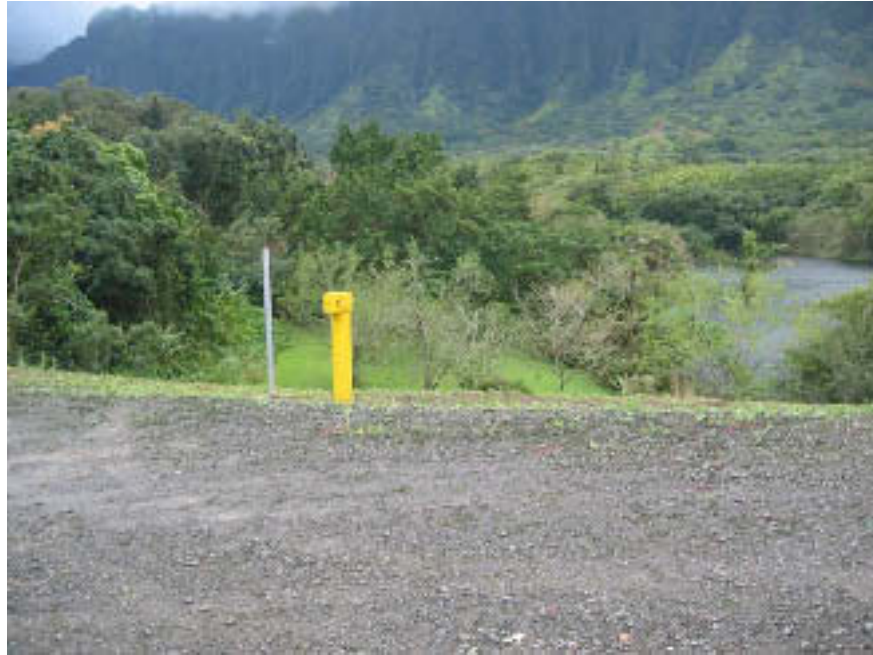
Sta. 14+00, Crest of dam overview looking at reservoir.
Piezometric tubes have been repainted.

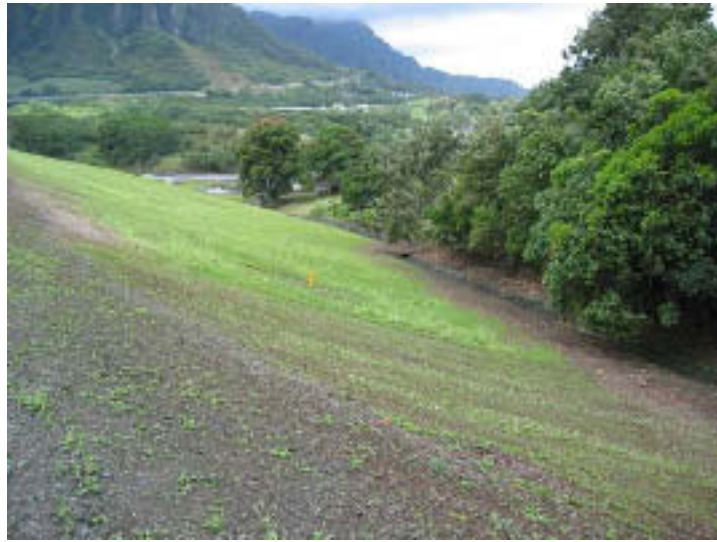
#21. Sta. 20+50, Overview of town side slope and piezometer tube

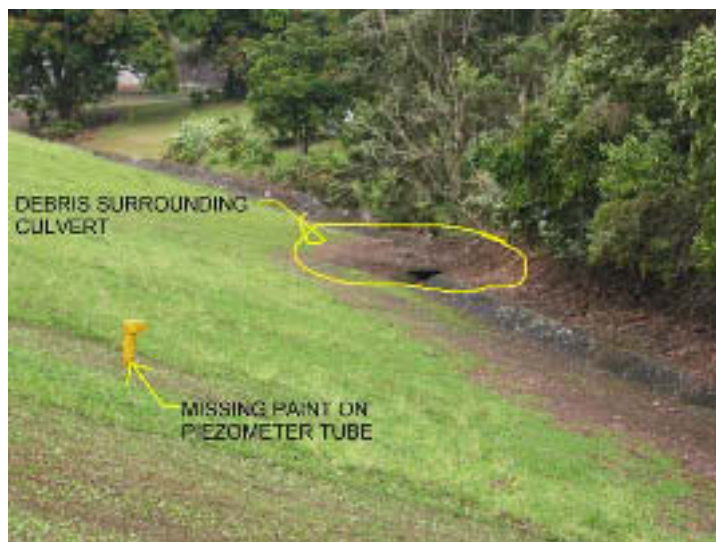
Paint chipped off portion of piezometer tube #21 and remove debris from surrounding culvert used for town side interior drainage.

Dam - Townside Toe	20+00	Paint weathered paint portion of Piezometer tube #21.
Dam - Townside Toe	20+00	Remove debris from culvert.
Stream Mouth, LB	3+00	Add more and larger rip rap to eroded area.
Stream Mouth, LB	6+00	Remove concrete step encroachment.
Stream Mouth, LB	6+25	Remove concrete step encroachment and add

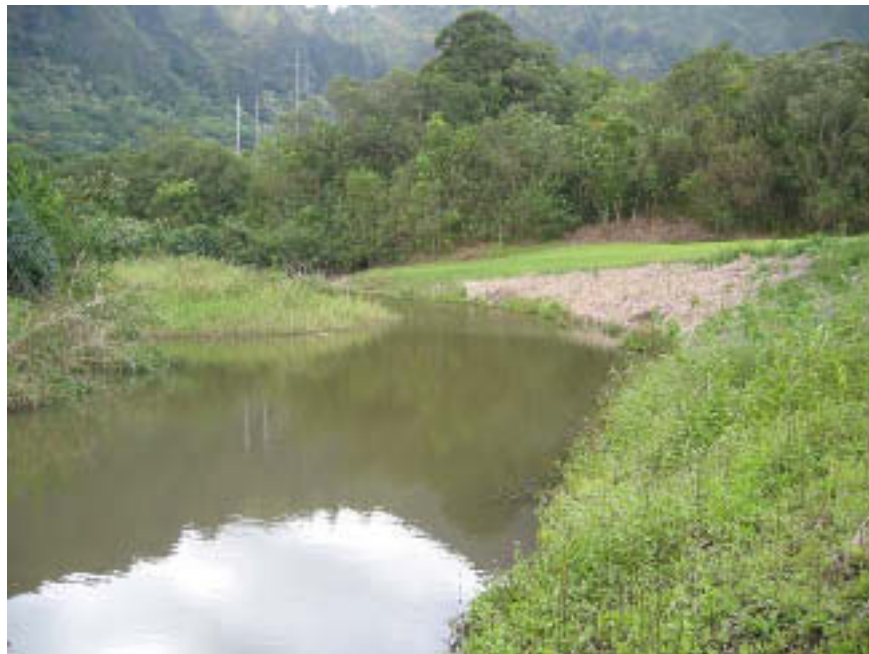
Overview of wildlife pond.
